**Traditional Reserve Study
For
Windward Community Development District
Kissimmee, Florida
May 15, 2024**

Report Number: 2024.05.15.234

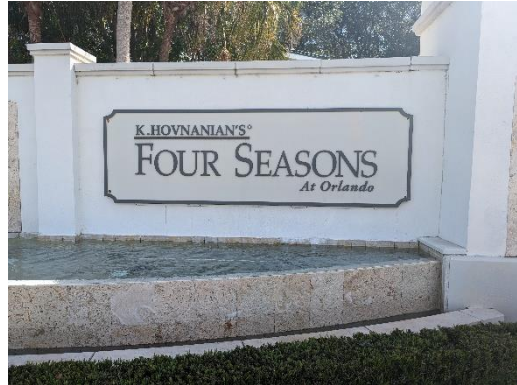
Entrance Signage

- **Entrance Signage** – There are four entrance signs, 2 on the west side and 2 on the south side. They appear to be in good condition.
- **Exterior Painting and Waterproofing, Monuments** – There are approximately 20,236 square feet of exterior painting on all the monuments throughout the community as well as both sides of the east side concrete perimeter wall. It appears to be in good condition.

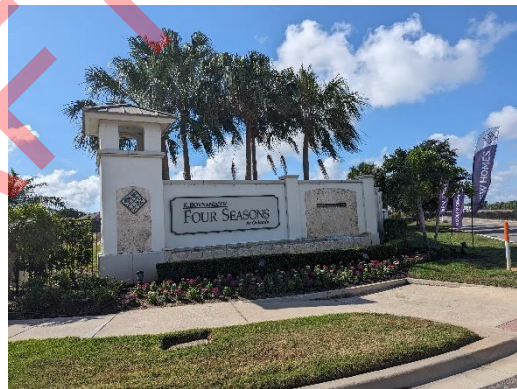
Entrance Monuments

- **Entrance Monuments, Allowance, Partial** – This accounts for all entrance monuments throughout the community. The west side entrance monuments are slightly cracked in several areas, but overall, the monuments are in good condition. The estimated remaining useful life is 65 years and so the total replacement cost is excluded from the study. A periodic failure rate of 5% every 3 years is included in the study as the estimated costs are significant.

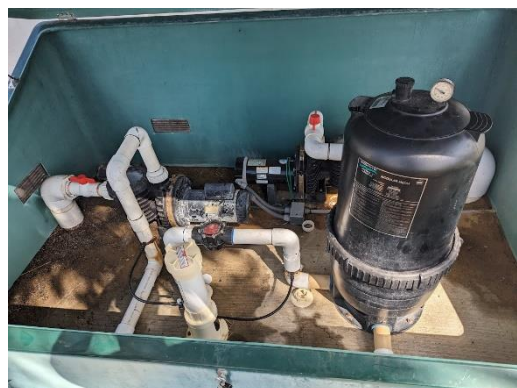
Fountain Equipment

- **Fountain Equipment** – This includes the pumps, motors, and filters for both entrance monument fountains. They appear to be in good condition.
- **Gate Motors, East Gate** – There are 4 gate motors at the south entrance. They appear to be in very good condition.

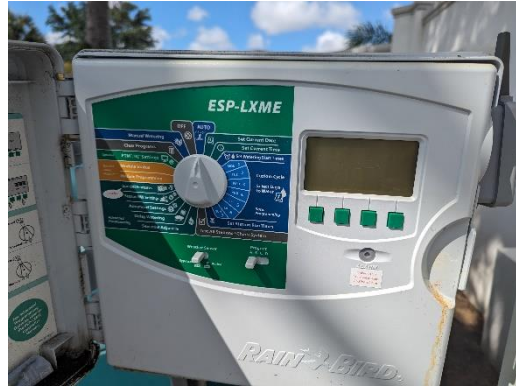
Irrigation

- **Gate Motors, South Gate** – There are 4 gate motors at the east entrance. They appear to be in very good condition.
- **Irrigation, Allowance** – There are 18 irrigation controllers. They appear to be in good condition.

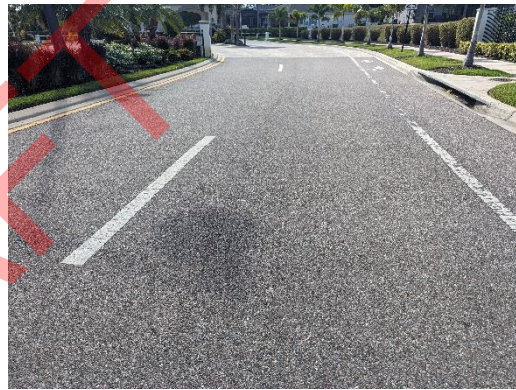
Asphalt Pavement

- **Asphalt Pavement, Crack Repair, Seal and Coat** – There is approximately 71,450 square yards of asphalt pavement. There is some staining, but overall, it is in very good condition.

- **Asphalt Pavement, Mill and Overlay** – There is approximately 71,450 square yards of asphalt pavement. It does not appear to have sealant.
- **Backflow Preventer** – There is one backflow preventer located by the south entrance. It appears to be in very good condition.

The Association may be able to mill and overlay the asphalt pavement prior to replacement. Milling and overlaying asphalt pavement is significantly less expensive than replacement, with approximately the same useful life if the asphalt pavement is maintained properly.

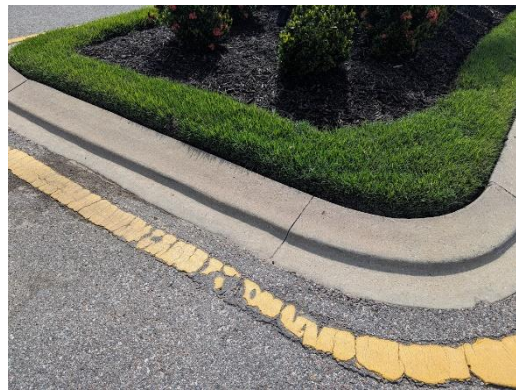
Curbs and Road Gutters

- **Curbs and Road Gutters, Partial** – There is approximately 63,000 linear feet of concrete curbs and road gutters. They are in very good condition. The estimated remaining useful life is 50 years and so the total replacement cost is excluded from the study. A periodic failure rate of 5% every 3 years is included in the study as the estimated costs are significant.

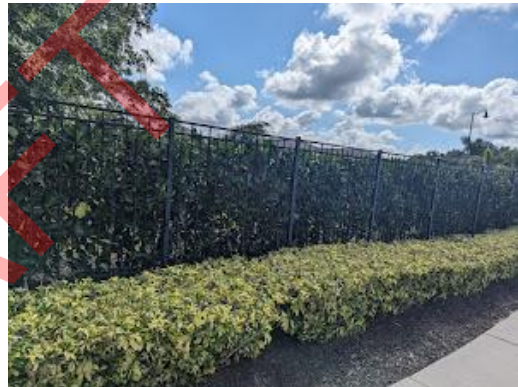
Aluminum Fencing

- **Fencing, Aluminum** – There are approximately 7,600 linear feet of aluminum fencing in common areas such as near entrance gates and perimeter fencing. There are some areas that are damaged on the west side of the property, but overall, it is in good condition.

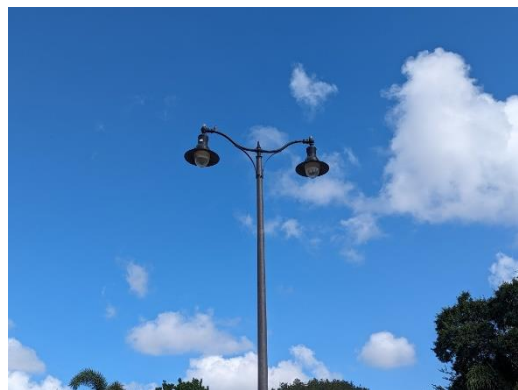
Streetlights

Excluded from study. Responsibility of utility company.

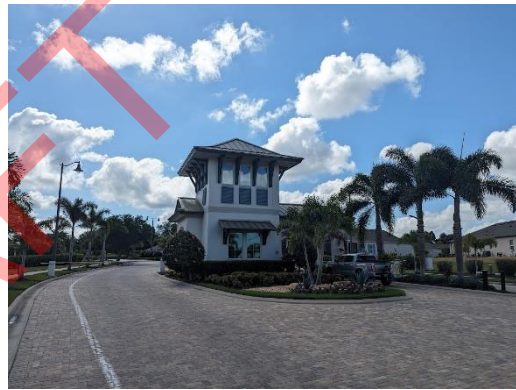
Security Building Exterior Paint

- **Exterior Painting and Waterproofing** – There are approximately 2,640 square feet of exterior painting on the security building. It appears to be in fair condition.
- **HVAC, 2 Ton** – There is one 2-ton Lennox heat pump for the security building. It appears to be in good condition.
- **Roof, Metal** – There are approximately 23 squares of metal roofing on the security building and the entrance monuments. It appears to be in good condition.
- **Security Building Allowance** – This allowance provides for the remodeling of the security building, including lights, windows, doors, flooring, bathroom, and other related components. It appears to be in good condition.

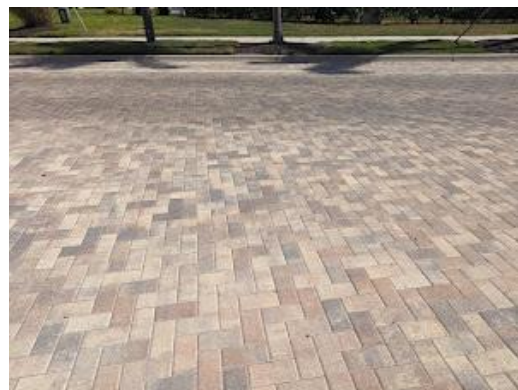
Road Pavers

- **Road Pavers** – There are approximately 28,856 square feet of pavers. They appear to be in good condition.
- **Security Camera System, Allowance** – This accounts for the replacement of security cameras at the entrances. They appear to be in good condition.

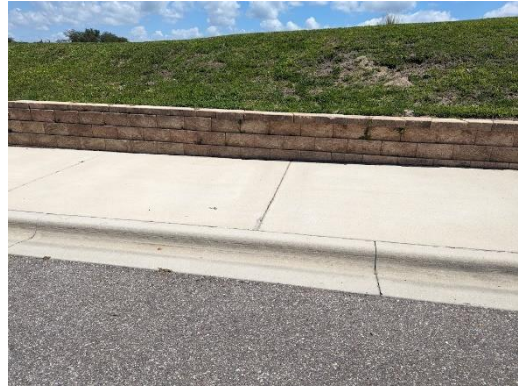
Retaining Wall (Common Area)

- **Pond Restoration** – There are approximately 4 acres of ponds throughout the property. They appear to range from good to fair condition.
- **Retaining Walls, Common Areas, Partial** – There are approximately 4,619 square feet of stone retaining walls located in common areas such as Four Seasons Blvd and the south entrance area. They appear to be in very good condition. The estimated remaining useful life is 65 years and so the total replacement cost is excluded from the study. A periodic failure rate of 5% every 3 years is included in the study as the estimated costs are significant.

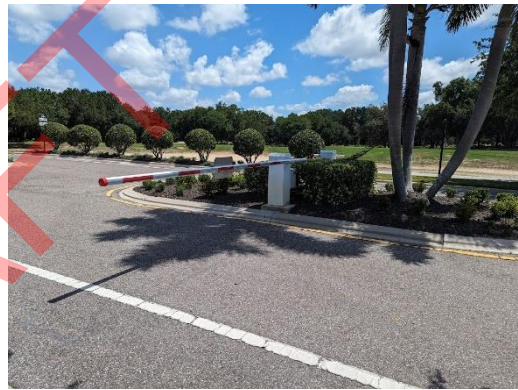
Entrance Gate Barrier

- **Barrier Gates, North Gate** – There are 2 barrier gates on the north side entrance. There is no visible manufacturer label. They appear to be in good condition.

- **Barrier Gates, West Gate** – There are 5 barrier gates on the east side entrance. There is no visible manufacturer label. They appear to be in good condition.

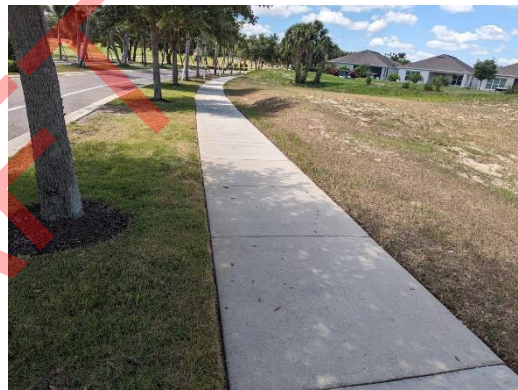
Sidewalks

- **Sidewalks, Concrete, Partial** – There are approximately 235,000 square feet of concrete sidewalks. There are some broken sections, but overall, it appears to be in good condition. The estimated remaining useful life is 65 years and so the total replacement cost is excluded from the study. A periodic failure rate of 5% every 3 years is included in the study as the estimated costs are significant.

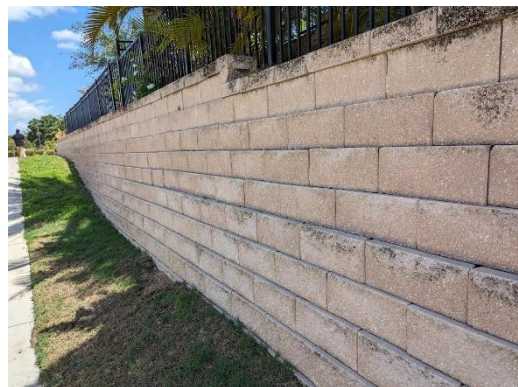
Retaining Wall and Fencing (Residential Areas)

- **Fencing, Aluminum, Residential Areas** – There is approximately 1,065 linear feet of aluminum fencing located behind residential areas. They appear to be in good condition.

- **Retaining Walls, Residential, Partial** – There is approximately 7,753 square feet of stone retaining walls located behind homes. They appear to be in very good condition. The estimated remaining useful life is 65 years and so the total replacement cost is excluded from the study. A periodic failure rate of 5% every 3 years is included in the study as the estimated costs are significant.

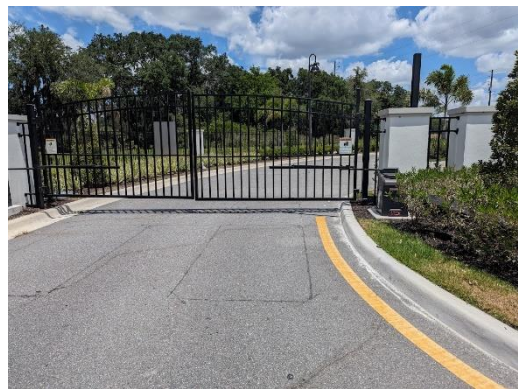
Entrance Gates

- **Dog Park Fencing, Chain Link** – There is approximately 360 linear feet of chain link fencing. It appears to be in very good condition.
- **Entrance Gates, East Entrance** – There are 4 entrance gates at the east entrance. They are in very good condition.

- **Entrance Gates, South Entrance** – There are 4 entrance gates at the south entrance. They are in very good condition.

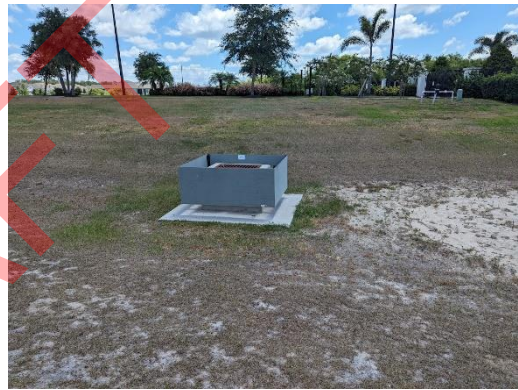
Stormwater System

- **Stormwater System, Cleaning, and Inspection** – This allowance provides for the cleaning and inspecting of the stormwater system. No plans provided. Price can vary depending on pipe size, type, length, heavy cleaning vs. light cleaning and whether plugging and draining is required. We recommend contacting a third-party vendor for an exact quote.

- **Stormwater System, Repairs Allowance** – This allowance provides for the repairs of the stormwater system. No condition assessment is available. We recommend contacting a third-party vendor for cleaning and inspection to determine the number of repairs that need to be made.
