**Traditional Reserve Study
For
Windward Community Development District
Kissimmee, Florida
May 15, 2024**

Report Number: 2024.05.15.234

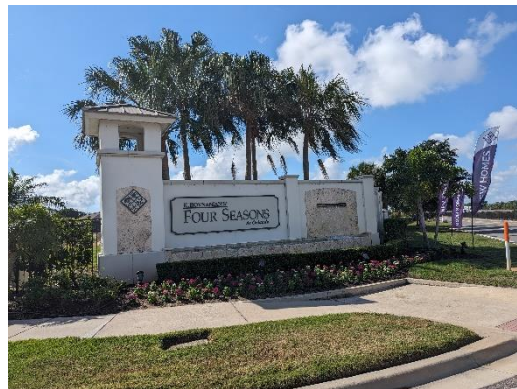
ID: 002

- **Entrance Monuments, Allowance, Partial** – This accounts for all entrance monuments throughout the community. The west side entrance monuments are slightly cracked in several areas, but overall, the monuments are in good condition. The estimated remaining useful life is 65 years and so the total replacement cost is excluded from the study. A periodic failure rate of 5% every 3 years is included in the study as the estimated costs are significant.

Entrance Monuments

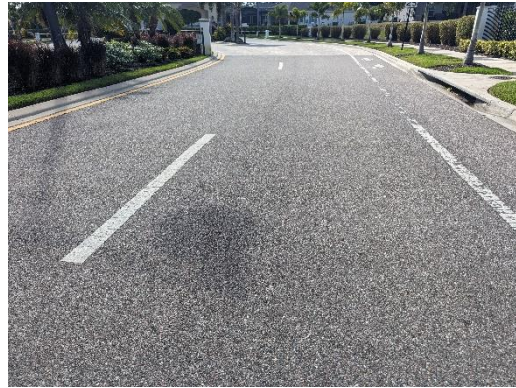
ID: 005

- **Asphalt Pavement, Crack Repair, Seal and Coat** – There is approximately 71,450 square yards of asphalt pavement. There is some staining, but overall, it is in very good condition.

- **Asphalt Pavement, Mill and Overlay** – There is approximately 71,450 square yards of asphalt pavement. It does not appear to have sealant.
- **Backflow Preventer** – There is one backflow preventer located by the south entrance. It appears to be in very good condition.

Asphalt Pavement

The Association may be able to mill and overlay the asphalt pavement prior to replacement. Milling and overlaying asphalt pavement is significantly less expensive than replacement, with approximately the same useful life if the asphalt pavement is maintained properly.

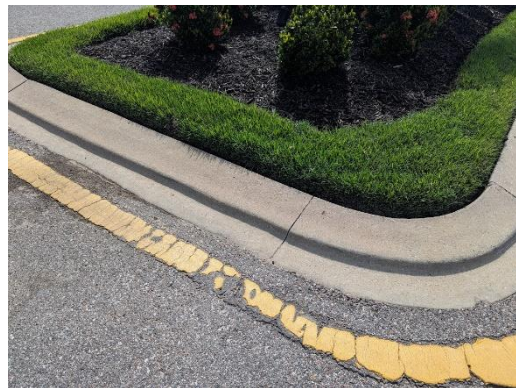
ID: 006

- **Curbs and Road Gutters, Partial** – There is approximately 63,000 linear feet of concrete curbs and road gutters. They are in very good condition. The estimated remaining useful life is 50 years and so the total replacement cost is excluded from the study. A periodic failure rate of 5% every 3 years is included in the study as the estimated costs are significant.

Curbs and Road Gutters

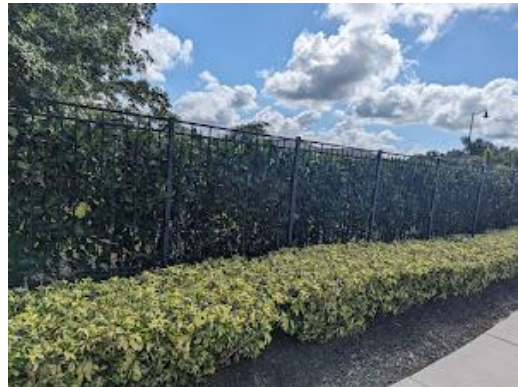
ID: 008

- **Fencing, Aluminum** – There are approximately 7,600 linear feet of aluminum fencing in common areas such as near entrance gates and perimeter fencing. There are some areas that are damaged on the west side of the property, but overall, it is in good condition.

Aluminum Fencing

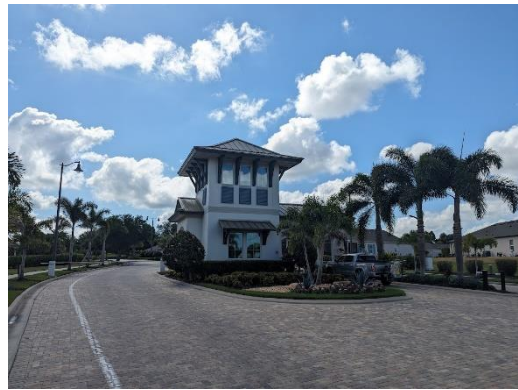
ID: 011

Security Building Exterior Paint

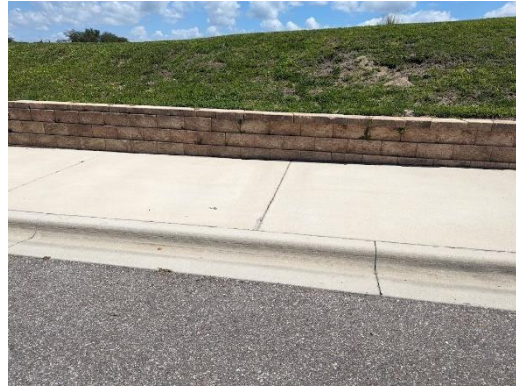
ID: 016

Retaining Wall (Common Area)

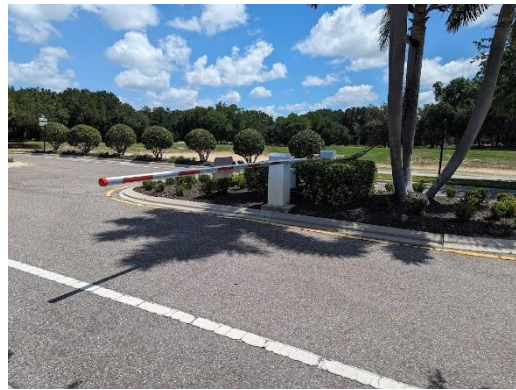
ID: 017

- **Barrier Gates, North Gate** – There are 2 barrier gates on the north side entrance. There is no visible manufacturer label. They appear to be in good condition.

- **Barrier Gates, West Gate** – There are 5 barrier gates on the east side entrance. There is no visible manufacturer label. They appear to be in good condition.

Entrance Gate Barrier

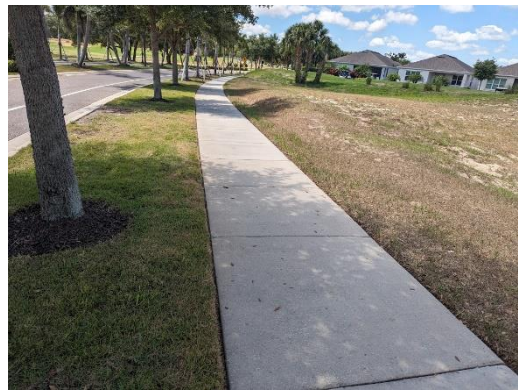
ID: 020

- **Sidewalks, Concrete, Partial** – There are approximately 235,000 square feet of concrete sidewalks. There are some broken sections, but overall, it appears to be in good condition. The estimated remaining useful life is 65 years and so the total replacement cost is excluded from the study. A periodic failure rate of 5% every 3 years is included in the study as the estimated costs are significant.

Sidewalks

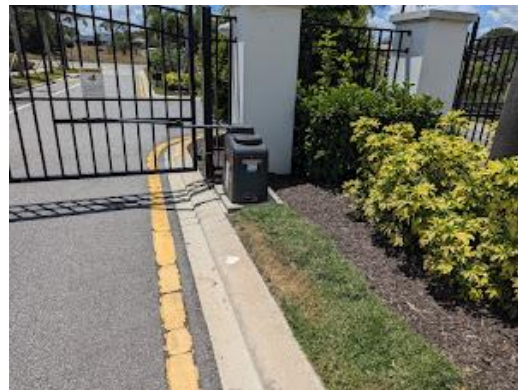
ID: 023

- **Fountain Equipment** – This includes the pumps, motors, and filters for both entrance monument fountains. They appear to be in good condition.
- **Gate Motors, East Gate** – There are 4 gate motors at the south entrance. They appear to be in very good condition.

- **Gate Motors, South Gate** – There are 4 gate motors at the east entrance. They appear to be in very good condition.
- **Irrigation, Allowance** – There are 18 irrigation controllers. They appear to be in good condition.

Entrance Gate Motors

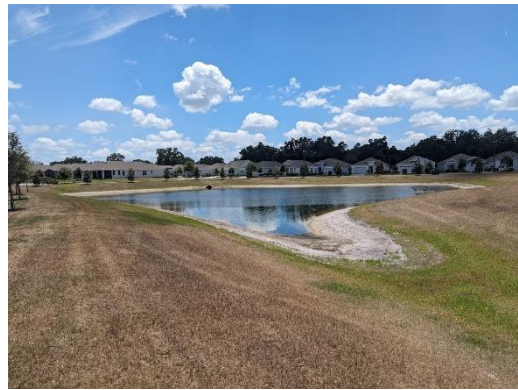
ID: 026

- **Pond Restoration** – There are approximately 4 acres of ponds throughout the property. They appear to range from good to fair condition.
- **Retaining Walls, Common Areas, Partial** – There are approximately 4,619 square feet of stone retaining walls located in common areas such as Four Seasons Blvd and the south entrance area. They appear to be in very good condition. The estimated remaining useful life is 65 years and so the total replacement cost is excluded from the study. A periodic failure rate of 5% every 3 years is included in the study as the estimated costs are significant.

Ponds

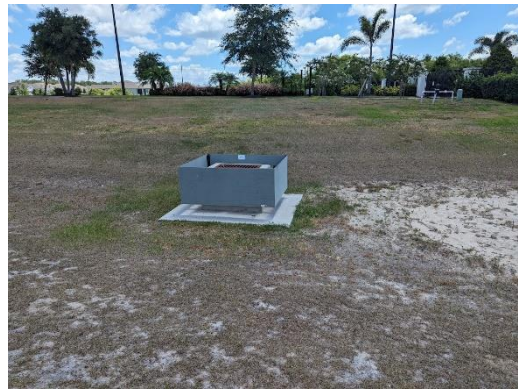
ID: 029

- **Stormwater System, Repairs Allowance** – This allowance provides for the repairs of the stormwater system. No condition assessment is available. We recommend contacting a third-party vendor for cleaning and inspection to determine the number of repairs that need to be made.

Stormwater System

- **Stormwater System, Cleaning, and Inspection** – This allowance provides for the cleaning and inspecting of the stormwater system. No plans provided. Price can vary depending on pipe size, type, length, heavy cleaning vs. light cleaning and whether plugging and draining is required. We recommend contacting a third-party vendor for an exact quote.
